## MonArc Project Report 2019

Monitoring of Arctic Infrastructure  
(MonArc – project duration 2017-2019)

### Monitoring of Arctic Infrastructure

**KEYWORDS:**Infrastructure,  
permafrost,  
foundations,  
monitoring, climate  
change, Svalbard,  
Arctic.**VERSION**

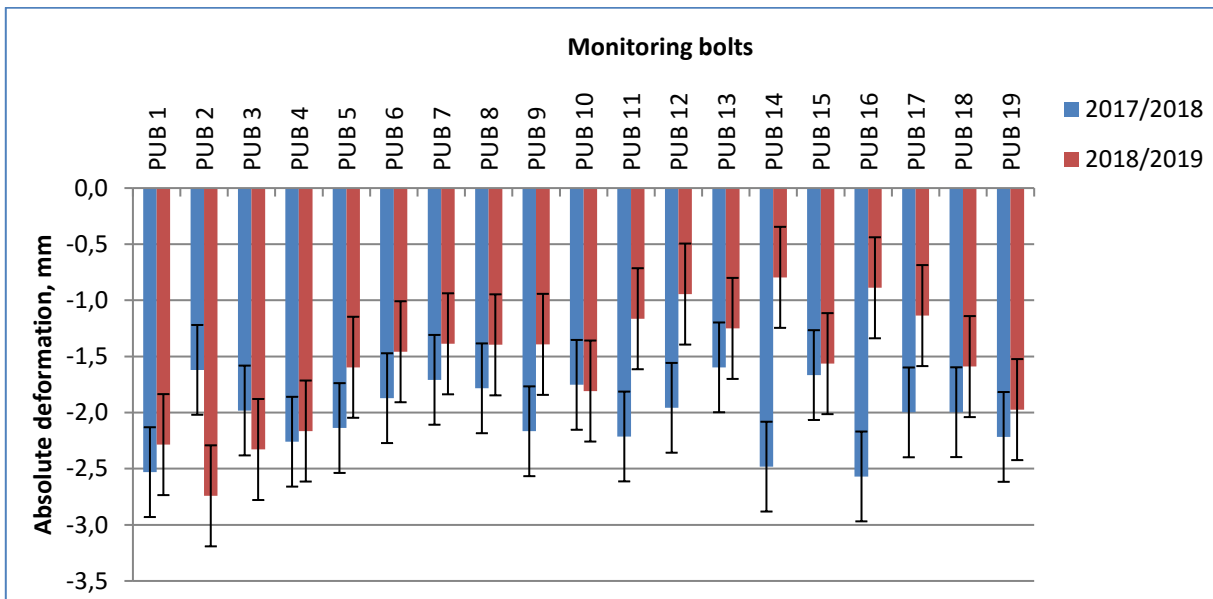
Absolute displacement and errors of measurements of the monitoring points under the multi-purpose garage are in the range 1-2,5 mm/year, with decrease in magnitude for 2018–2019 in comparison to 2017–2018. The latter is opposite to the situation at the outer walls. Settlements under the central part of the garage are smaller than at the outer walls. One may suggest that permafrost conditions are colder (and hence the settlements of piles are smaller) under the building compare to the outer walls due to drier conditions and better surface conditions (absence of snow in the wintertime).

Figure 7. Absolute displacements of monitoring points (and errors of measurements) under the multi-purpose garage in Pyramiden in 2017-2018 and 2018-2019.

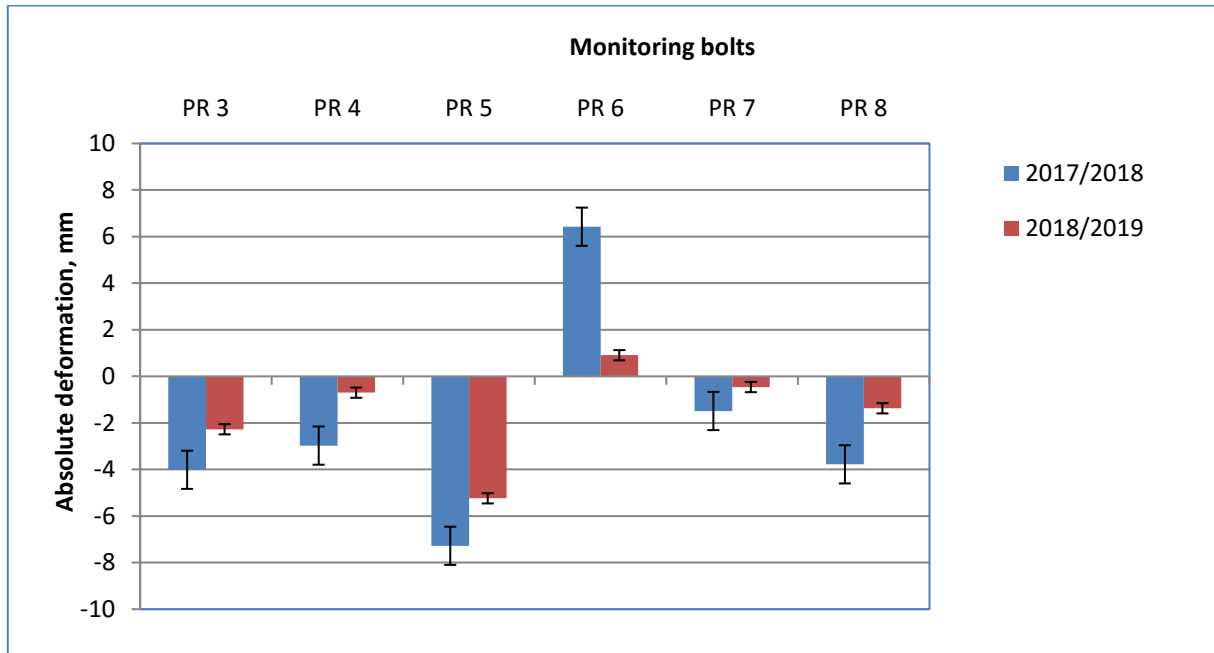
Settlements on stretch of the road were 1,5–7 and 0,5–5,2 mm/year in 2017–2018 and 2018–2019 respectively, frost heave was identified in the middle part of the stretch (monitoring point PR6) near a drainage culvert.

Figure 8. Absolute displacements of monitoring bolts on stretch of the road in Pyramiden.

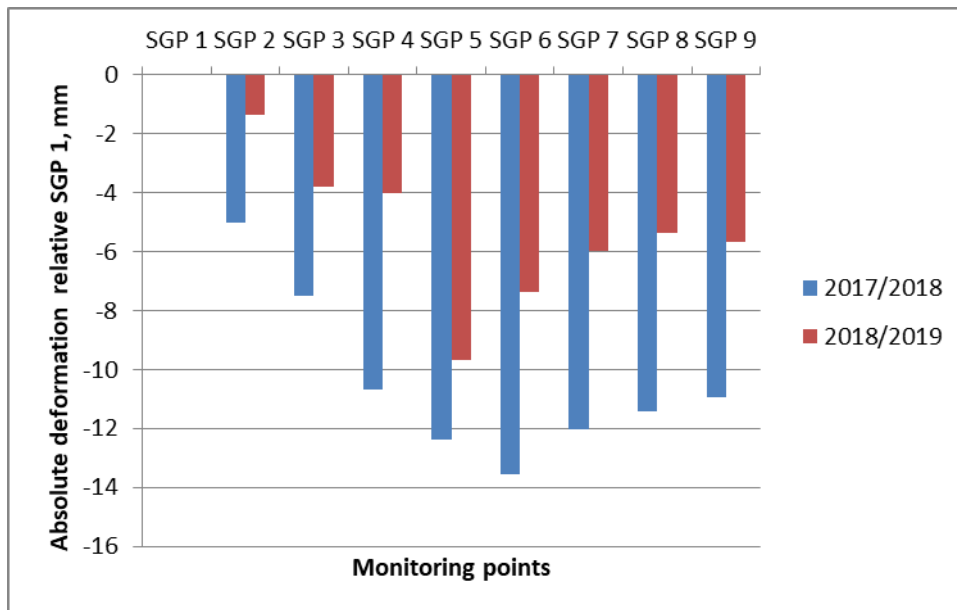
Absolute displacements on both sides of the garage (relative to the first points on each side) are presented in Figure 12–Figure 13. One can see significant differential (1–14 mm) vertical displacements on both sides of the garage in 2017–2018 and 2018–2019. Displacements were higher in 2017–2018. Largest displacements are noted on the right-hand side when one facing entrance of the garage (the entrance towards the airport).

Figure 12. Absolute displacements (SGP 1–SGP 9) at right-hand side of multi-purpose garage “Magnetittlageret”.

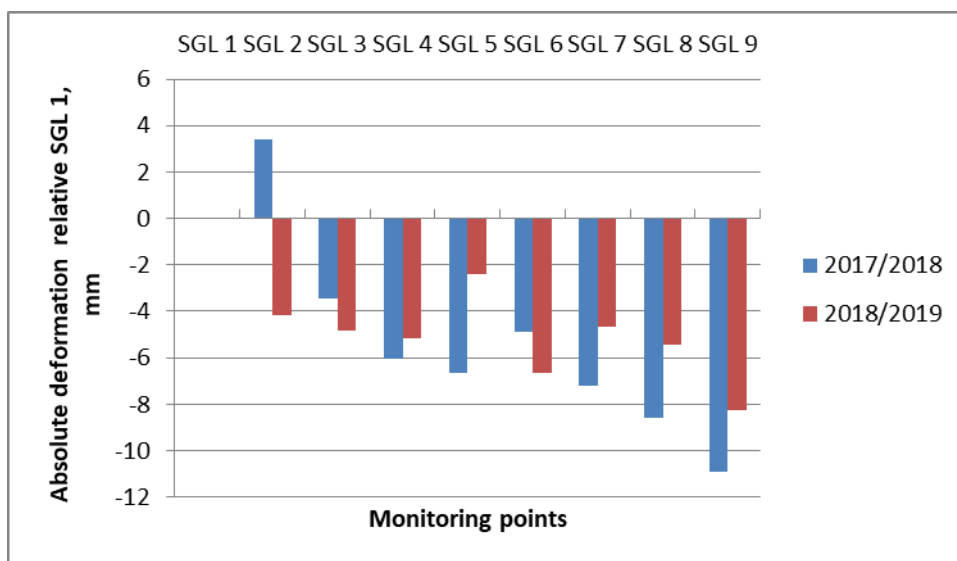
Figure 13. Absolute displacements (SGL1–SGL 9) at left-hand side of multi-purpose garage “Magnetittlageret”.

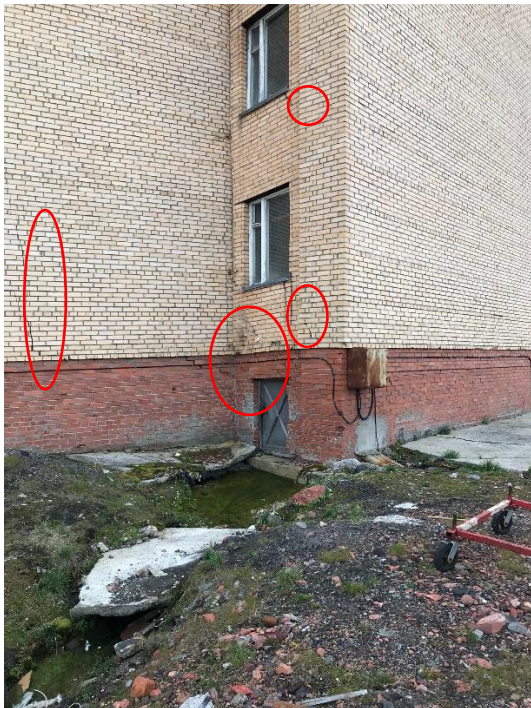
Cracks were observed in the northern part of the building, on the north (Figure 14) and east-facing walls (Figure 15). Drainage coming out from under the building was also observed at the north-facing wall (Figure 16–Figure 17). It seems that the drainage pattern might go somewhere under the building. However, no cracks were observed on outer walls in other parts of the building, hence presence of continuous drainage pattern under the building is questionable. Most probably this drainage also serves for water collected on the roof as the outer downpipes are absent; hence water must be conveyed by some downpipes located inside the building.

**Figure 16. Drainage coming from under the building "Komplex GRZ" in Barentsburg and cracks (highlighted with red circles).**

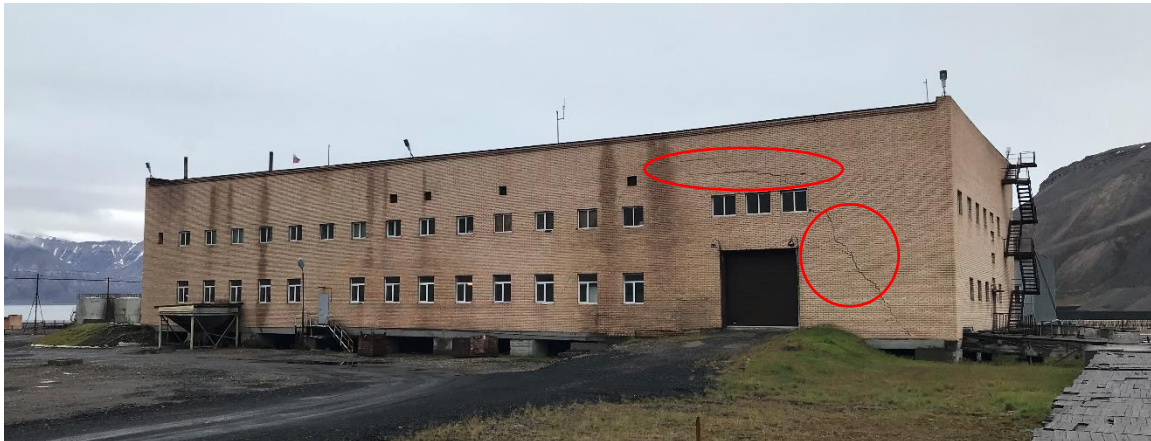
Cracks were observed in western part on the multi-purpose garage, on its north- (Figure 18) and south-facing walls (Figure 19). The following reasons might be outlined among the ones caused the cracks:

- Water leakages in the past (as warm water, sewage water) might be also among the reasons for settlements. Happening of water leakages (in ca. 2010) was mentioned by the maintenance staff, they told that water from the shower room was drained in the western part on the building for some time (perhaps weeks?).

- Possible presence of a talik zone under the western part of the building was pointed out by the owner of the building [4]. This idea may be supported by the fact that the thermosyphons were installed around several buildings in Pyramiden to improve permafrost conditions locally.

Figure 18. Cracks (highlighted with red circles) on the north-facing wall of the multi-purpose garage in Pyramiden.

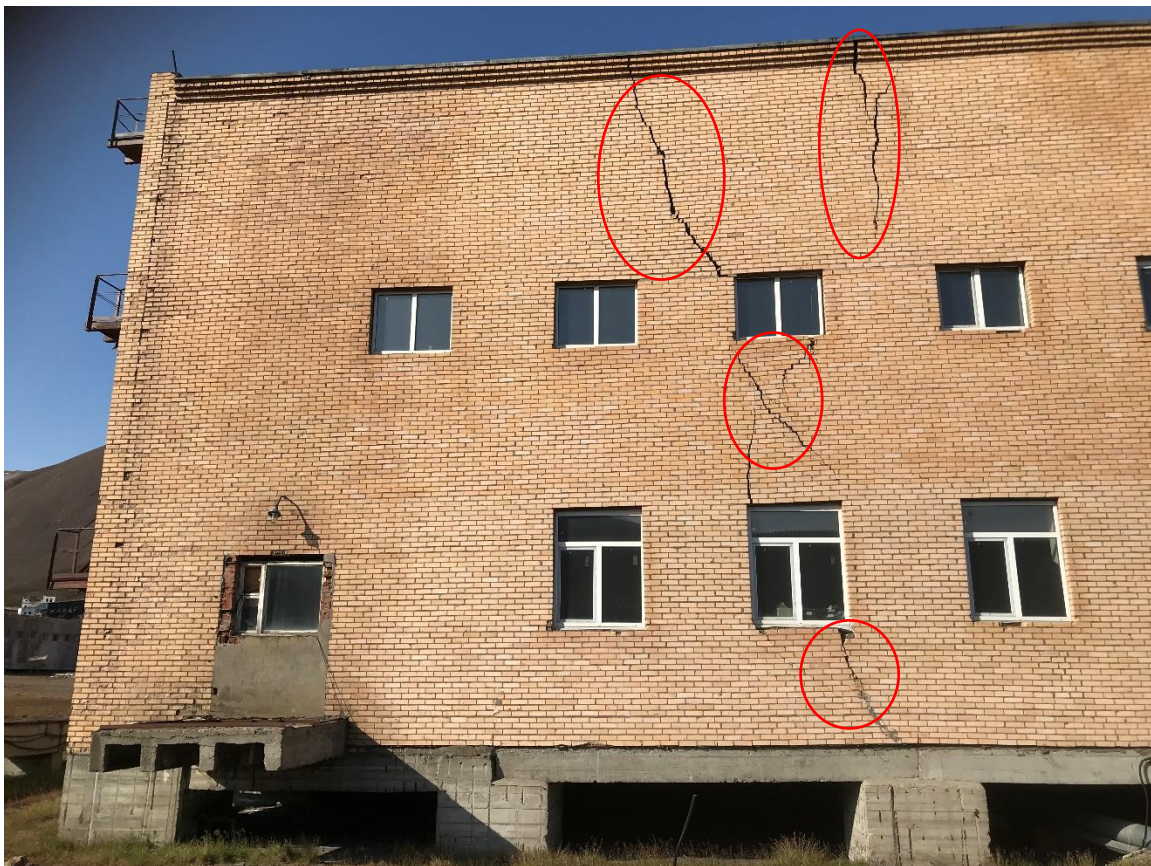
Figure 19. Cracks (highlighted with red circles) on the south-facing wall of the multi-purpose garage in Pyramiden.

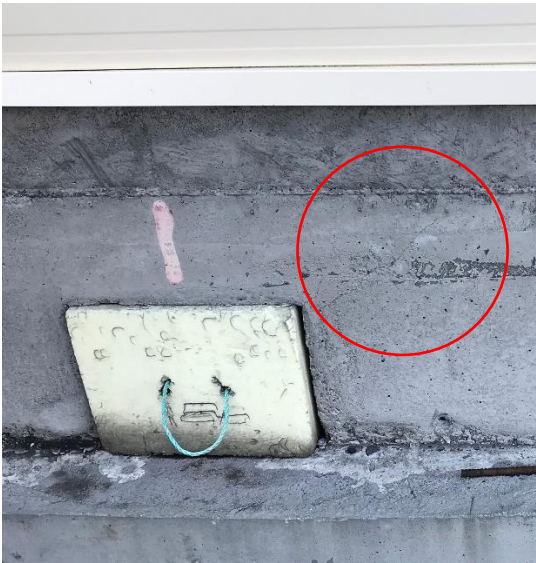
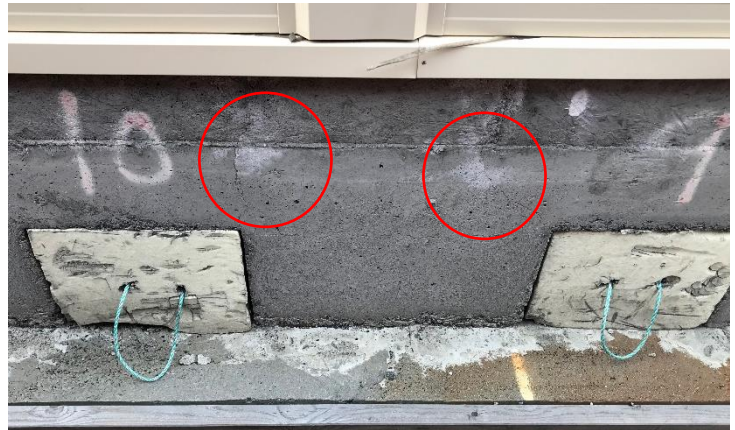
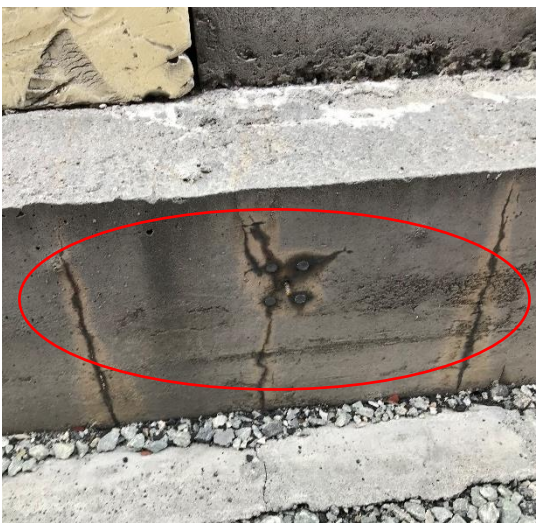
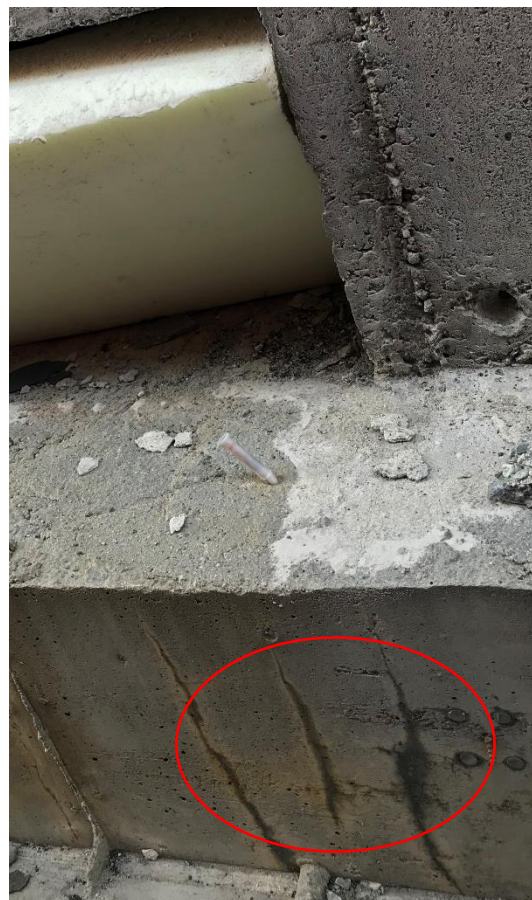
Only minor cracks were observed in several locations of shallow foundation of multi-purpose garage “Magnetittlageret” in Svea (Figure 20–Figure 23).

Figure 20. Cracks (highlighted with red circles) on foundation of the “Magnetittlageret” garage.
