MonArc Project Report 2017

Monitoring of Arctic Infrastructure

Enterprise /VAT No:
NO 948 007 029 MVA**KEYWORDS:**Infrastructure,
permafrost,
foundations,
monitoring, climate
change, Svalbard,
Arctic.**VERSION**
2017-01**DATE**
2017-12-31**AUTHOR(S)**

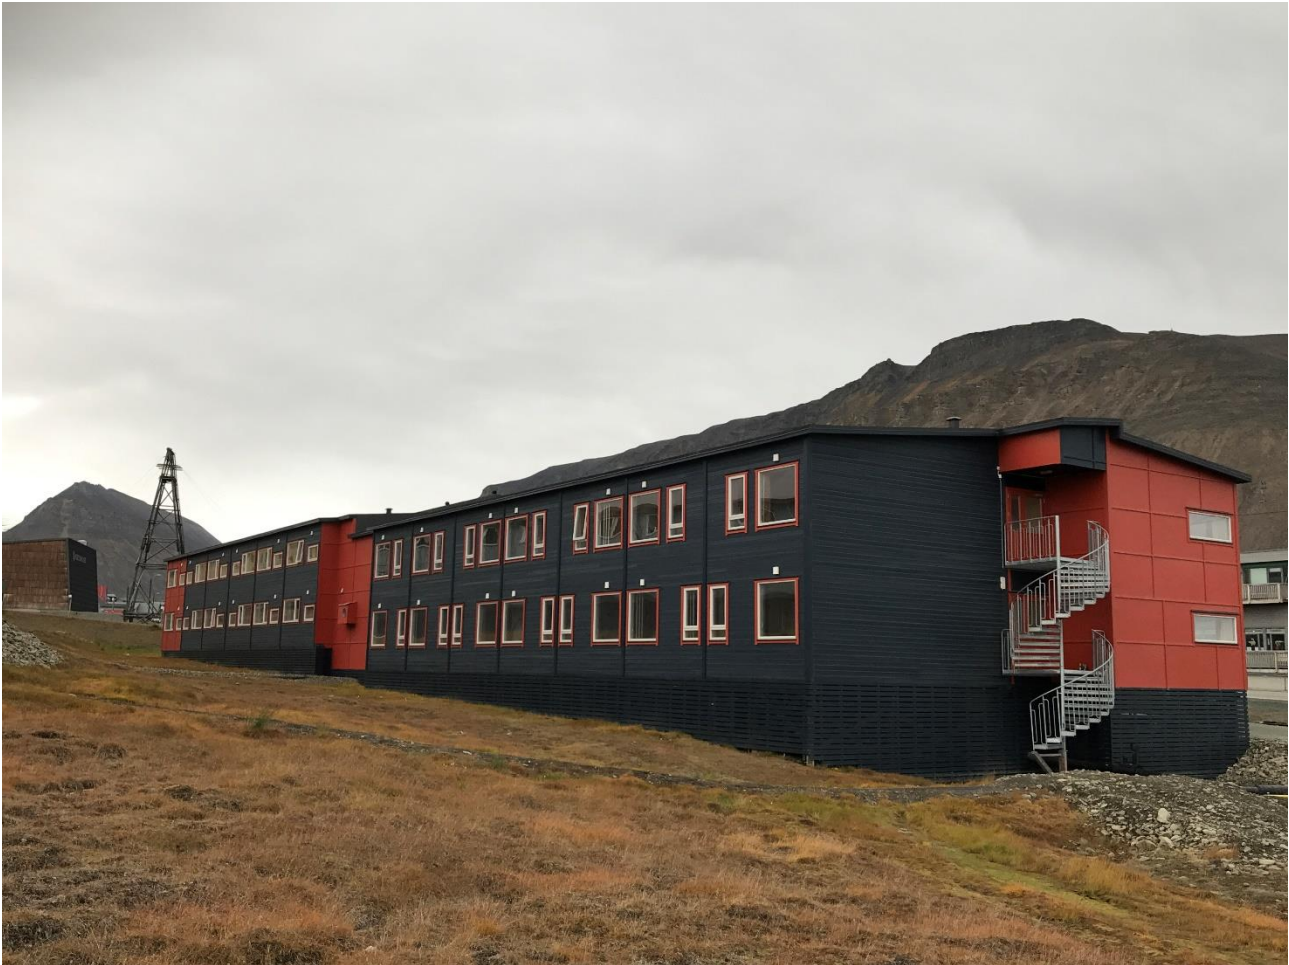
Figure 5. UNIS Guest House.

This building is a light-weight two-story wooden building (Figure 5) and the foundation is composed of wooden piles penetrating to a depth of ca. 9 m [17]. Crawl space is covered by decorative planks allowing free air flow below the building. Western side of building partially connected to road (Road 500) by ramp, partially disturbing the air flow. Dimensions of the building are approximately 15x70 m. The building was constructed in 2009–2011. The building is used for temporal accommodation.

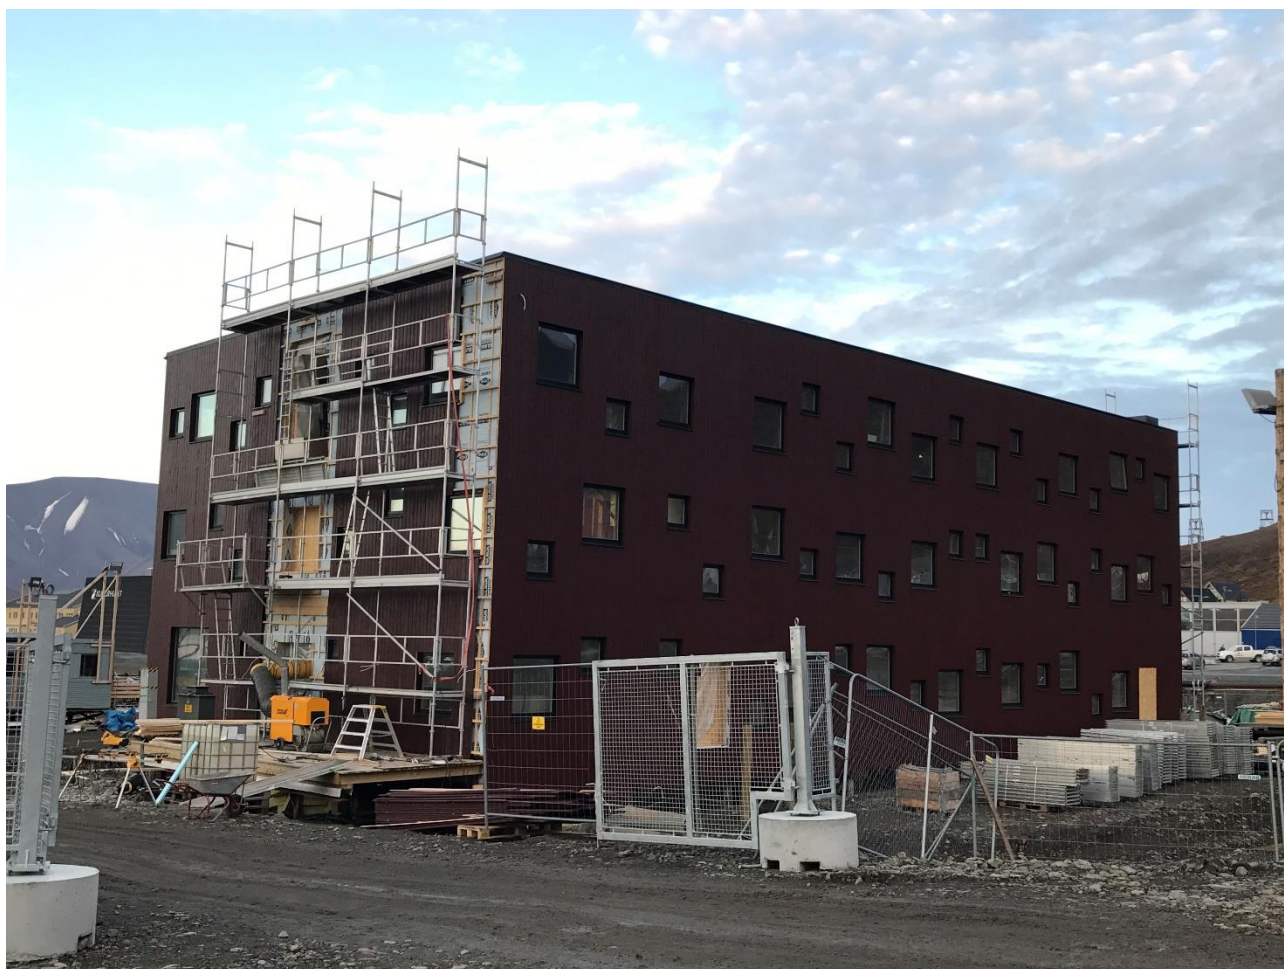
Figure 8. The building "Elvesletta Byggetrinn 1" of a new hotel in Longyearbyen.

The building is a Light-weight three-story wooden building (Figure 8) and foundation is composed of steel piles (140-mm square profile) penetrating to a depth of ca. 18 m. Crawl space is covered by decorative planks allowing for free air flow below the building. Dimensions of the building are approximately 16 x 30 m. The building was erected in 2016-2017. The building is used for temporal accommodation.

Remarks on special conditions: the building is located in proximity of the Longyear Elva. Icings (ca. 1 m thick, 50 m in diameter) were observed on the ground surface in the area next to the building (spring 2017).

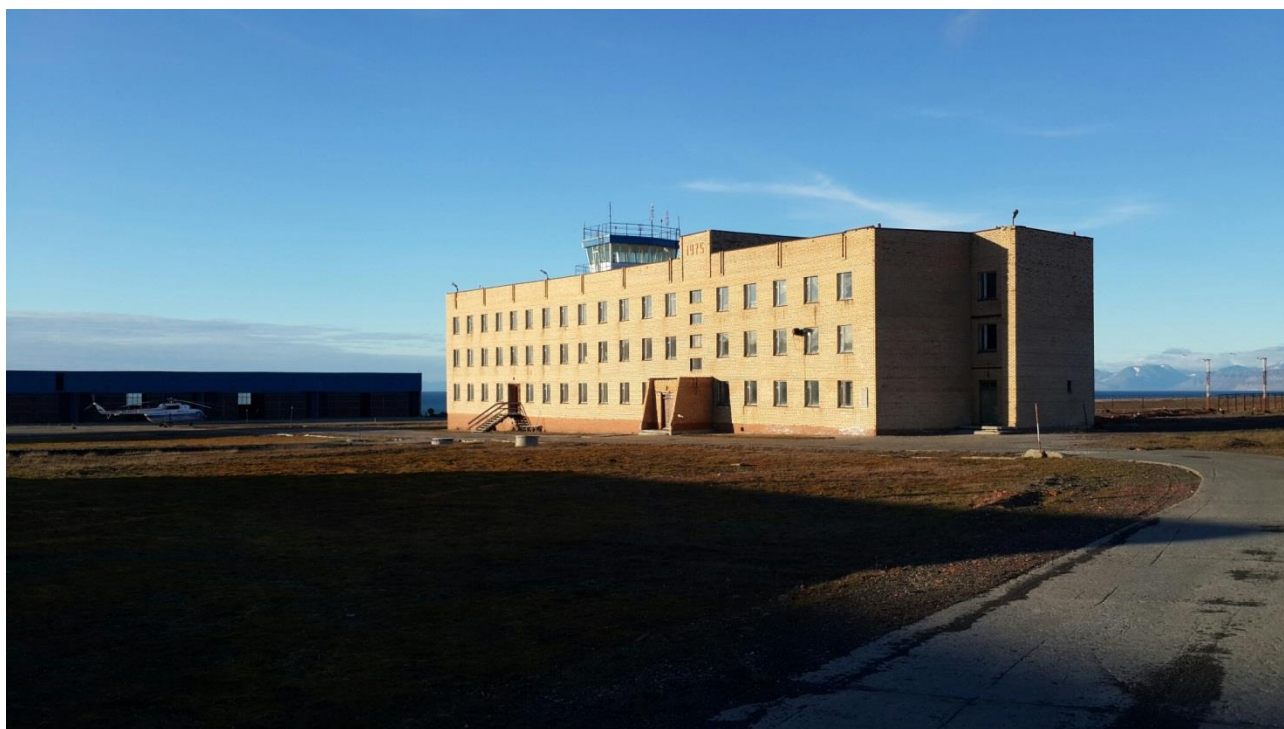
Figure 10. Building "Komplex GRZ" in Barentsburg.

Three-story building "Komplex GRZ", constructed in 1975–1978 was surveyed (Figure 10). Dimensions of the building are approximately 50 by 15 m. The building has brick walls installed on pillars, which are based on concrete piles. It is assumed that piles are 10 m long. Construction of basement prevents free flow of air in the crawl space. Cracks were observed in the wall facing the helipad. Reasons that caused the observed damage are unknown.

- To initiate (within the project)¹ monitoring of openings of cracks in the brick walls in Barentsburg and Pyramiden. Instrumentation will consist of installation of thin steel palets (consisting of two separate pieces) across visible cracks, and subsequent monitoring of its opening.
- For the leveling survey, it is strongly recommended to break the distance from the reference point to the buildings in equal intervals (for instance 25 m), the latter helps to minimize the measuring error.

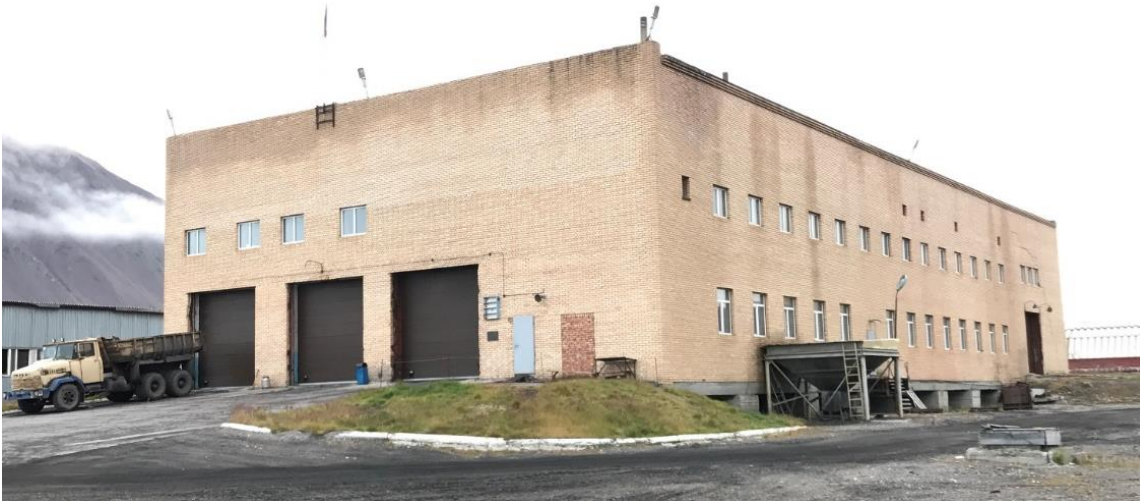
Figure 13. The multi-purpose garage in Pyramiden.

The building is a multi-purpose garage (Figure 13), which was built in 1981–1983. Brick walls of the building are installed on pillars, which are based on concrete piles. It is assumed that the piles are 10 m long, construction of the building permits free air flow in the crawl space. Cracks were observed on the western wall of the building.

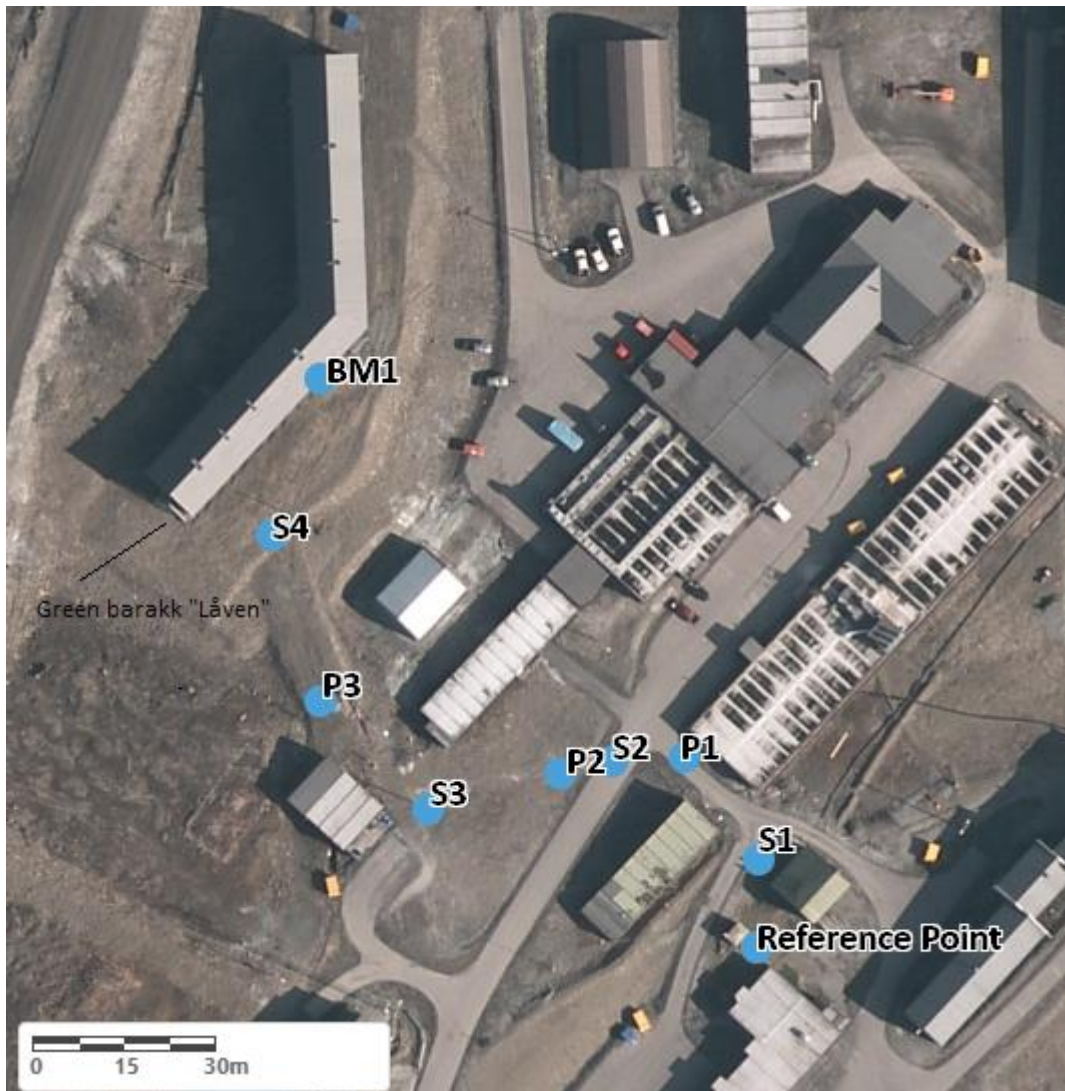
Figure 15. Map with the Låven barakk, way points, and reference points in Svea (Picture: after [14]).

Reference points used in Svea are presented in Appendix C (Figure 34–Figure 35). Route from the reference points towards the surveyed building is presented in Figure 15.

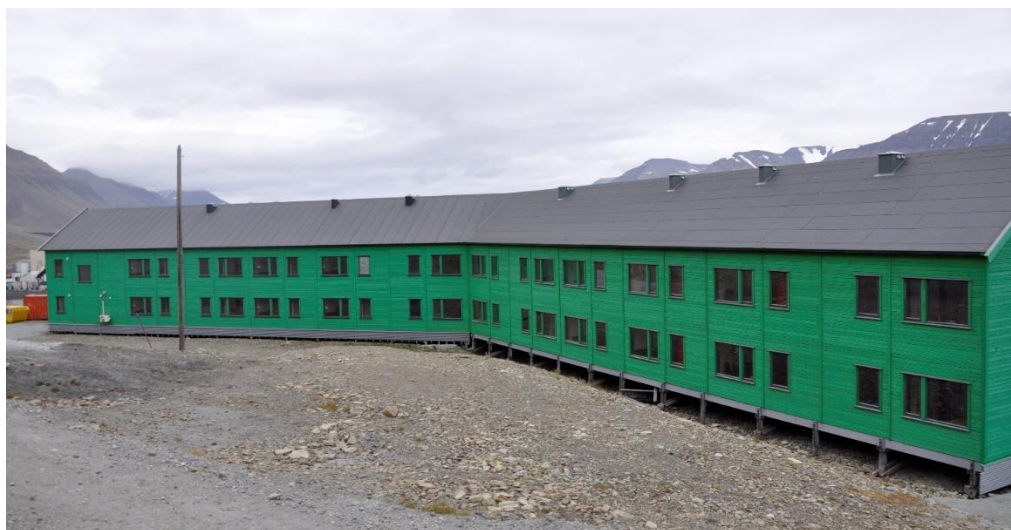
Figure 16. Building of the Låven barakk in Svea.

Two buildings were surveyed: building of the Låven barakk (Figure 16) and a multi-purpose garage (Figure 18).

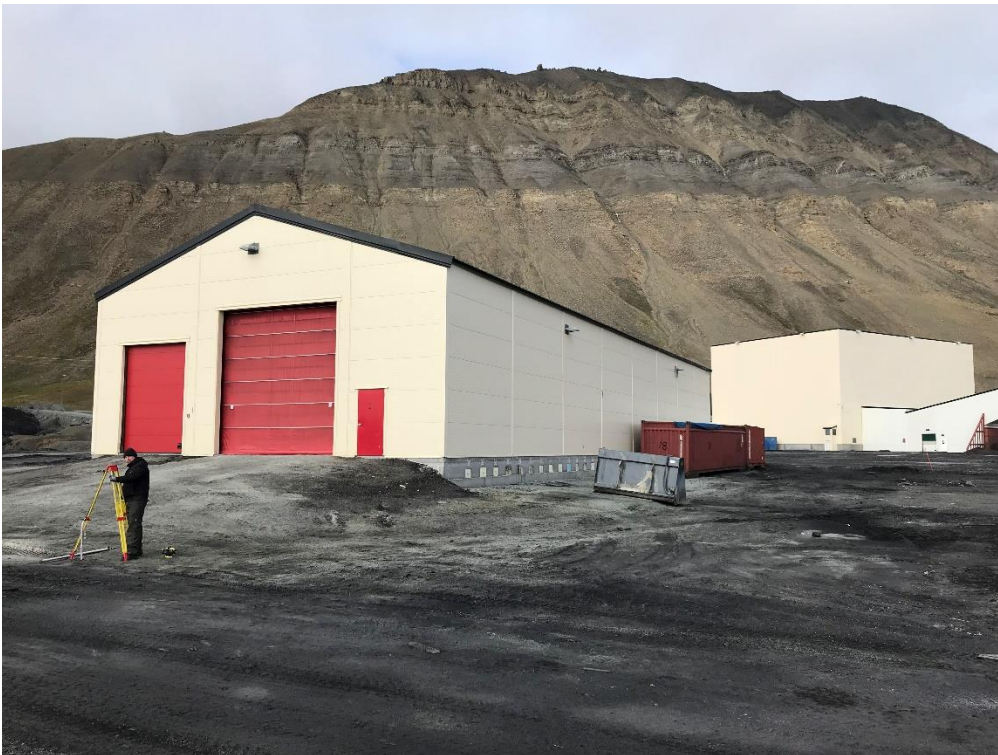
Figure 18. Multi-purpose garage in Svea.

The Multi-purpose garage (Figure 18) is used as storage of vehicles and equipment. It is a lightweight building, which has walls composed from metal panels. The building is located on shallow concrete foundation, which has ventilation channels throughout the whole buildings' foundation. Free air flow in winter is possible. In summer, the channels are blocked with styrofoam blocks to shelter the frozen ground from getting into direct contact with the warmer air surrounding the building.

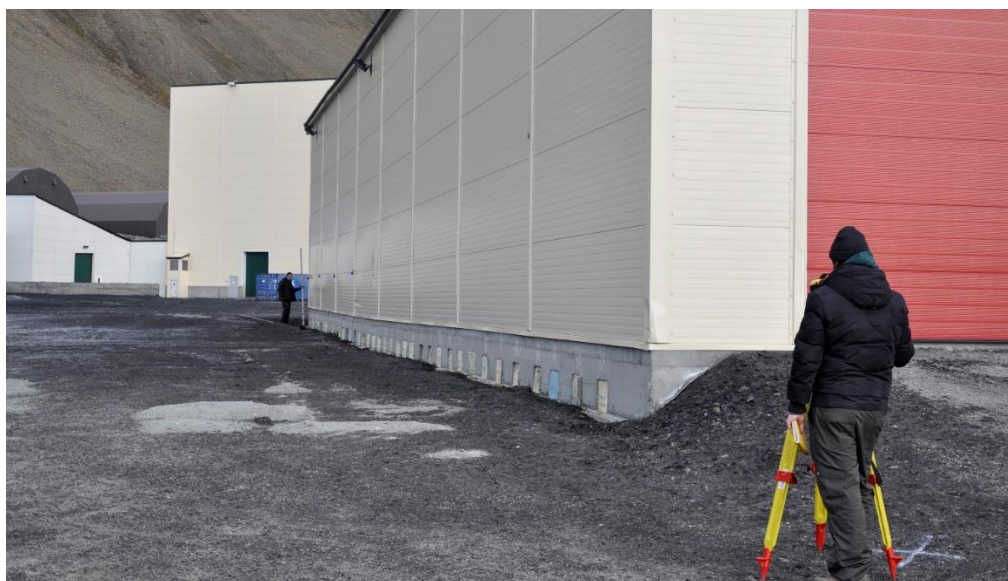
Figure 19. Survey on the multi-purpose garage in Svea.

Survey at the garage was carried out locally, i.e. elevations of its elements were not measured in relation to the reference point. Elevations of monitoring points were measured in relation to the building itself. The two long sides of the garage were surveyed (Figure 19). Survey on each side on the garage was performed in relation to the point located on the side, which was surveyed. Elevation of the foundation at each fifth ventilation channel was surveyed.

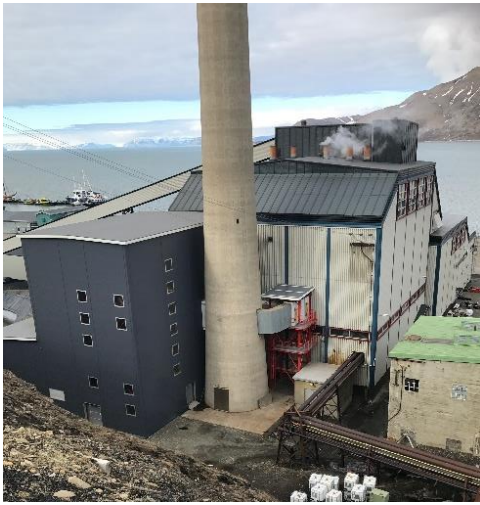
Figure 20. Location of the reference points in Longyearbyen: pipe of the power station.

One of two reference points, installed on/at the pipe of the power plant (Figure 20–Figure 22) was used for survey. Reference points were installed at the entrance of pipe of the power plant in Longyearbyen by Norwegian Polar Institute (designated as LRP1 in present report) and Geological Survey of Norway (designated as LRP2 in present report). Approximate coordinates: 78.2252° N; 15.6183° E.

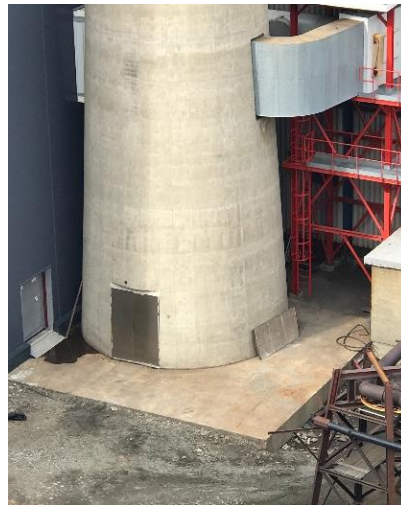
Figure 21. Location of the reference points in Longyearbyen.

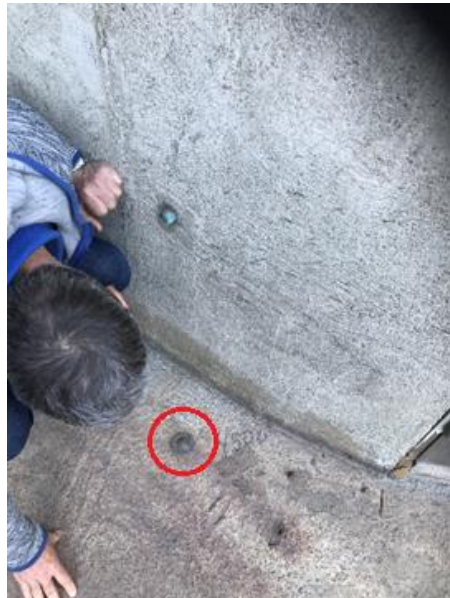
Figure 22. Circle points to the reference point at the entrance into the pipe of power plant in Longyearbyen. This point was used in the survey (LRP1).

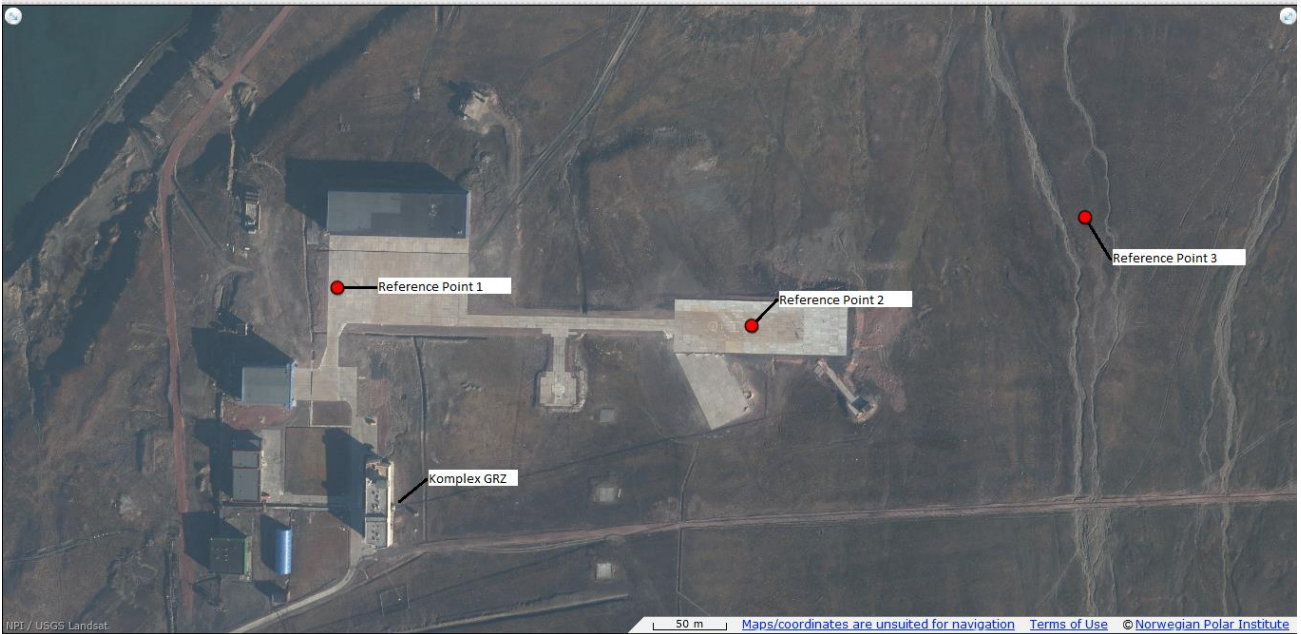
Figure 23. Reference points in Barentsburg (satellite image is from [17]).

Two standard reference points were located on the pavement of the helipad were used for survey (Figure 23–Figure 28):

- Reference point N1 (BRP1) "GUGK 1356" (33 X 0481425, UTM 8669812)
- Reference point N2 (BRP2) "GUGK 190(1?)" (33 X 0481705, UTM 8669778).

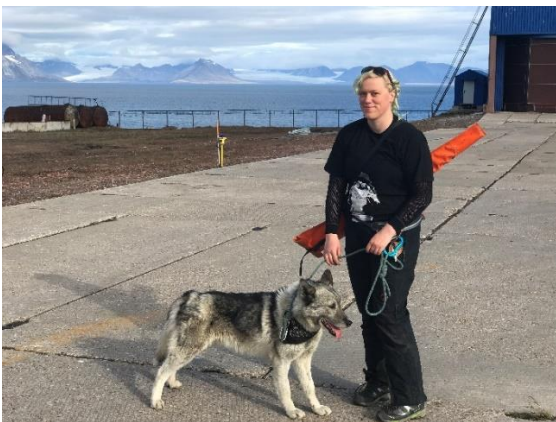
Figure 24. Katharina Beutner standing close to the Reference point N1 "GUGK 1356" (BRP1).

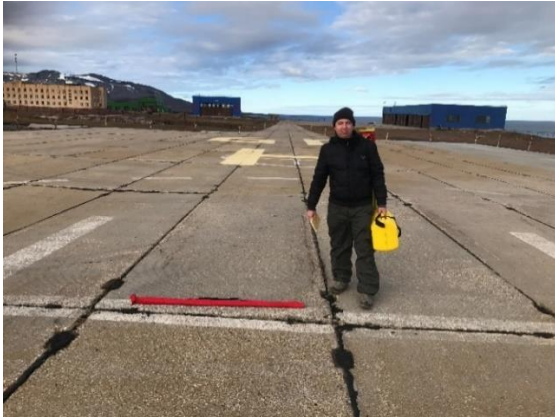
Figure 26. Pavel Kotov staying next to the Reference point N2 "GUGK 190(1?)" (BRP2).

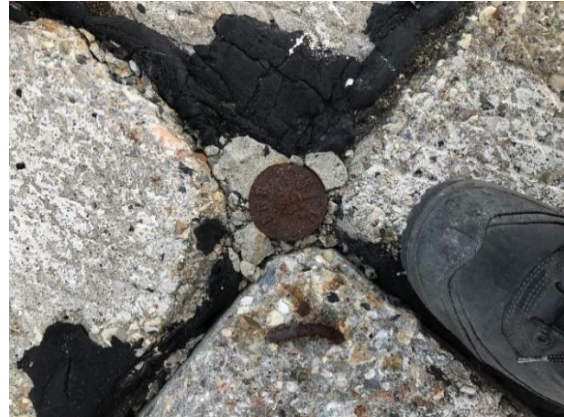
Figure 27. Reference point N2 "GUGK 190(1?)" (BRP2).

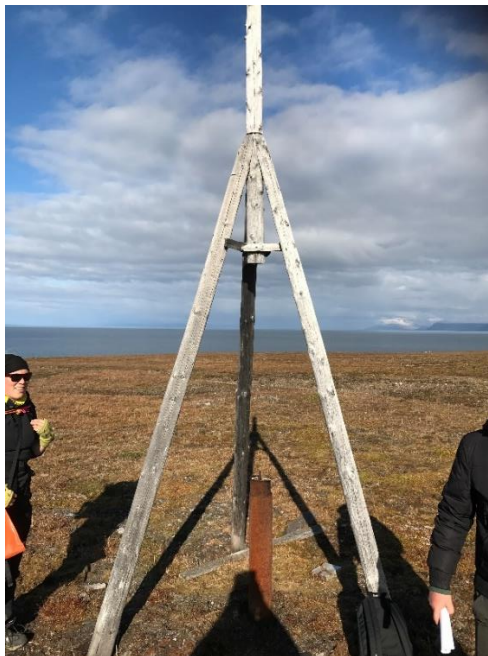
Figure 28. Reference point N3 "Pyramid at the sea coast" (BRP3).

In addition, several wooden structures called "pyramids" were noticed on a distance of 1–2 km uphill from the building. One may assume that the pyramids are installed to mark the standard reference points. Distance from the pyramids to the building was too large in to order to use them as reference points in the survey. Another pyramid termed as Reference point N3 "Pyramid at the sea coast" (33 X 0481948, UTM 8669832) is located in several hundred meters from the heliport and can be considered as a reference points for future surveys (Figure 28).

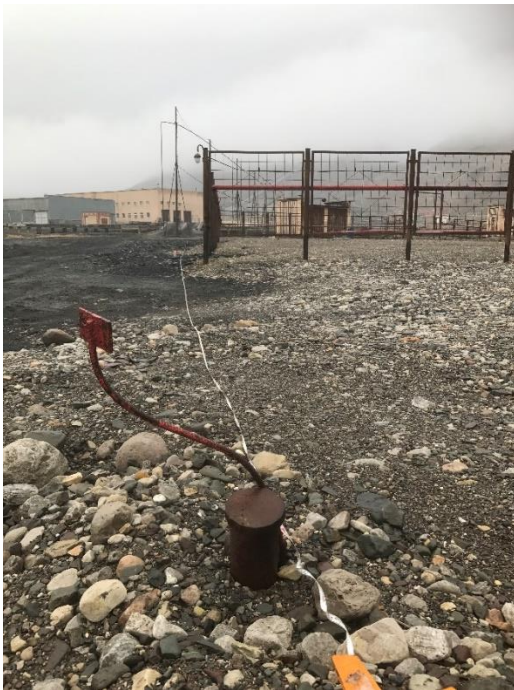
Figure 29. Reference point N1 (PRP1).

- Reference point N1 (PRP1), located at fence of oil tanks (33 X 0529579, UTM 8731566),.
- Reference point N2, located at an old steel borehole casing. It was decided in the end of fieldwork to exclude this point from the consideration due to arised doubts in the stability of the casing.
- Reference point N3 (PRP2), located on the top of the casing of old borehole (33 X 0529651, UTM 8731808). Short (ca 15 cm) steel rod welded to the top of casing was used as actual reference point. Barcode staff was installed in the middle part of this rod.
- Reference point N3 (PRP3), located at the base of the weather station.

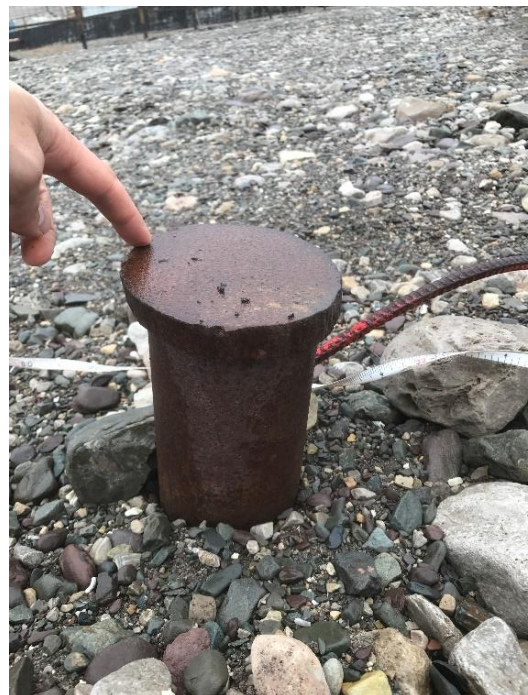
Figure 30. Reference point N1 (PRP1), finger pointing at the upper point of the platform, where the rod (barcode staff) was placed for performing the measurements.

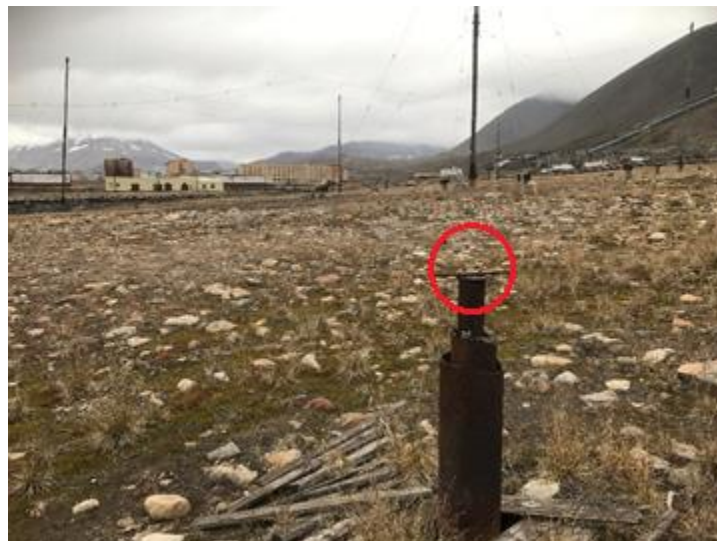
Figure 31. Reference point N3 (PRP3), circle points the bolt, on which the bar staff was placed for surveying.

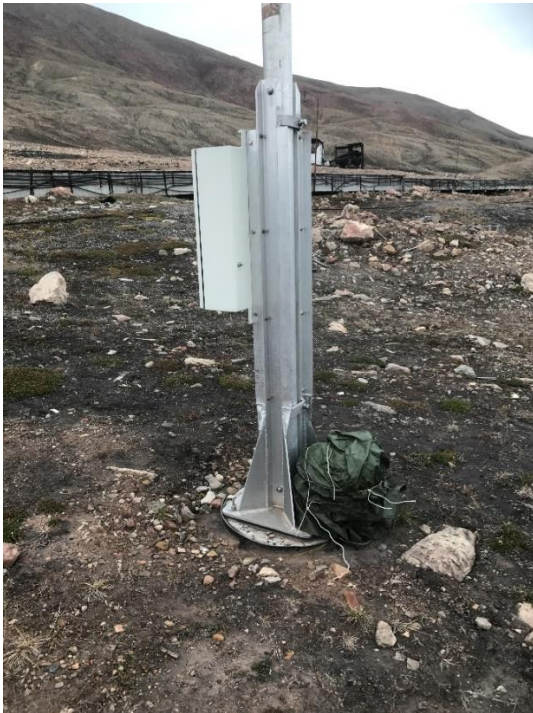
Figure 32. Reference point N4 (PRP4).

Four reference points in Pyramiden were used (Figure 12, Figure 29–Figure 33):

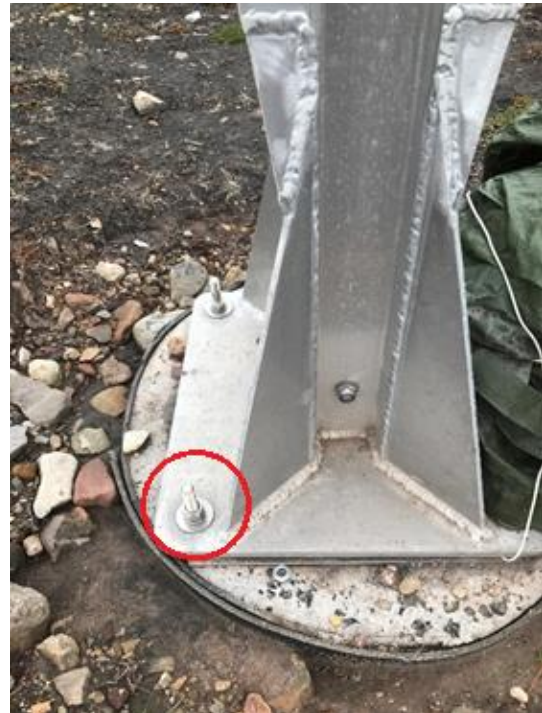
Figure 33. Reference point N4 (PRP4), arrow points on the bolt, on which the bar staff was placed for surveying.

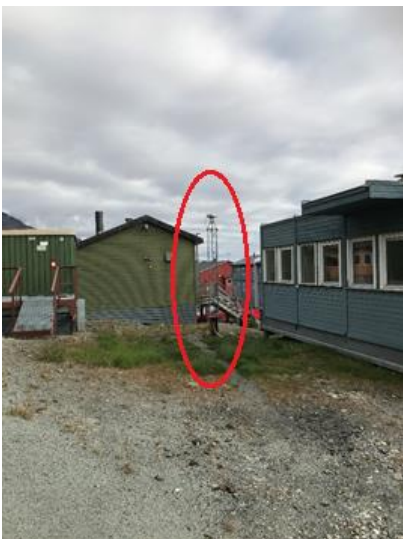
Figure 34. Reference point in Svea.

Reference point at the Store Norske office was used in Svea (Figure 34–Figure 35).

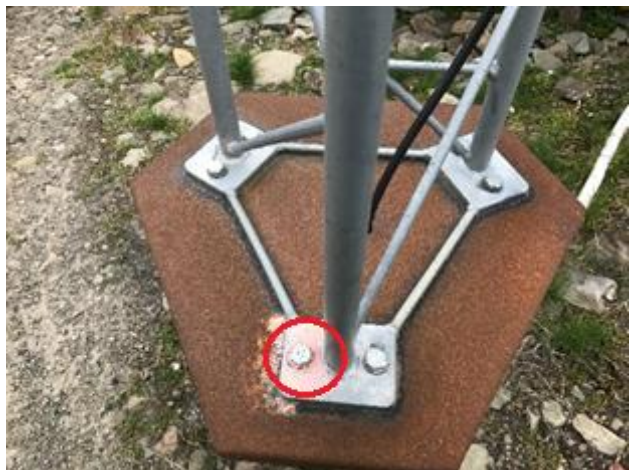
Figure 35. Circle points out the bolt, which was used for survey at the Reference point in Svea.
