## MonArc Project Report 2019

Monitoring of Arctic Infrastructure  
(MonArc – project duration 2017-2019)

### Monitoring of Arctic Infrastructure

**KEYWORDS:**Infrastructure,  
permafrost,  
foundations,  
monitoring, climate  
change, Svalbard,  
Arctic.**VERSION**

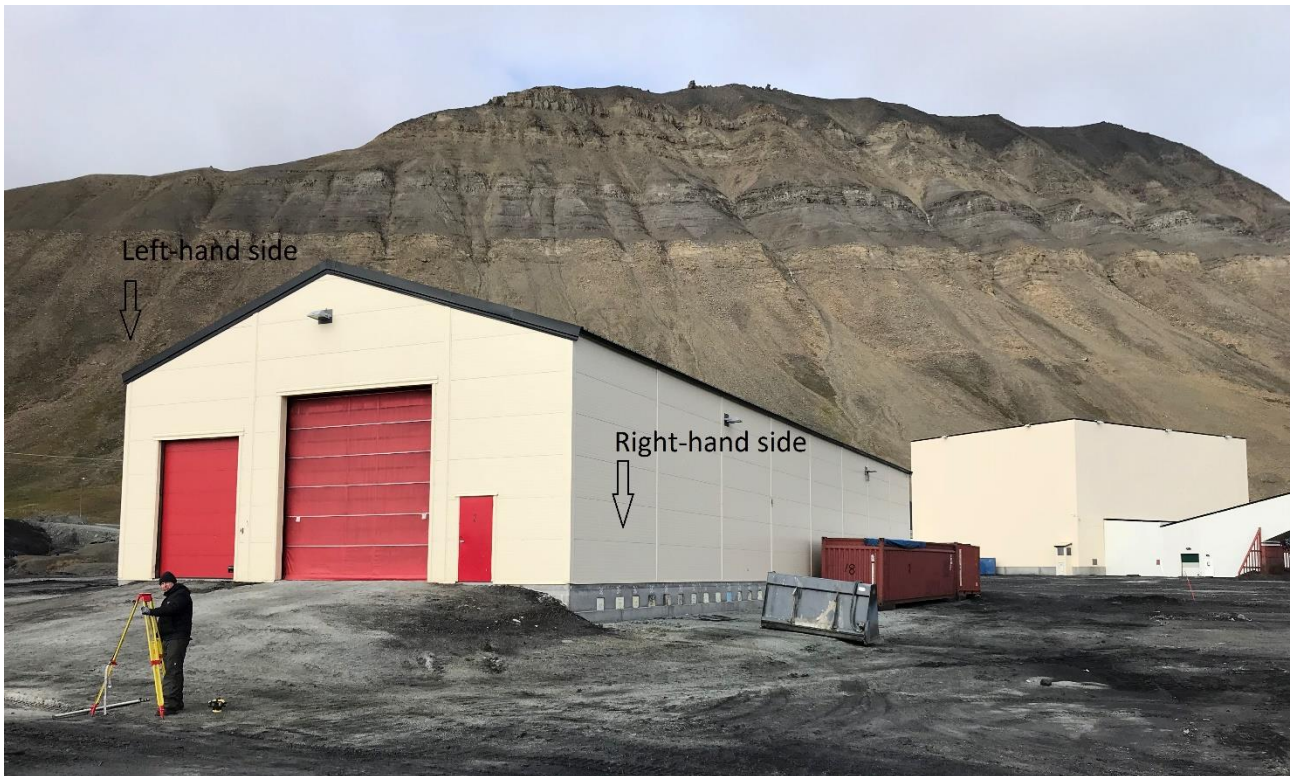
Figure 1. Multi-purpose garage "Magnetittlageret".

Multi-purpose garage "Magnetittlageret" is supported on a shallow concrete foundation (thick plate), which has several parallel ventilation channels going across the building length axis (see Figures 18–19 in [1]). We measured the settlement of the foundation relative to the foundation surface of the first channel (i.e., top of the channel – point SGP1 on the right-hand side, and point SGL1 on the left-hand side). Each side of the garage (Figure 1) was measured separately. Measurements were performed on the top of foundation opposite to the middle of each fifth channel (Figure 2), i.e. eight points were surveyed along each side of the garage.

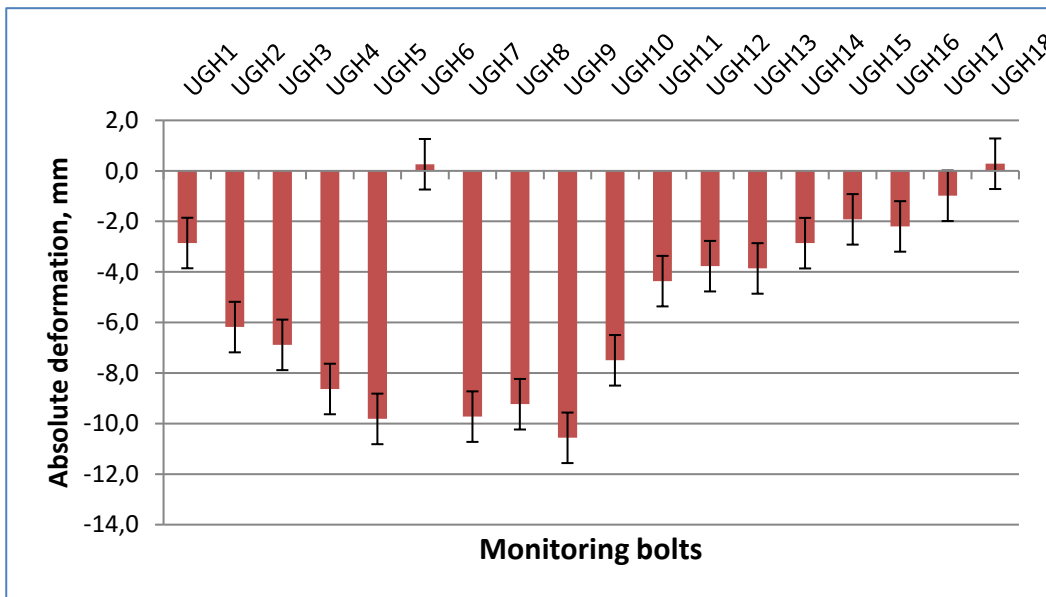
Only preliminary field survey was performed in Longyearbyen in 2017, the results of this survey could not serve as a solid base-line data set. Raw data and calculated elevations are presented in Excel file "Longyearbyen\_Raw data\_2018-2019". Elevations of monitoring bolts and standard errors of measurements for 2018–2019 are presented in Excel file "Longyearbyen\_Comparison\_2018–2019" and in Table 8. Absolute displacements are presented in Figure 3–Figure 4. Monitoring bolts of the UGH settled for 1,9–10,6 mm, and of the Vault Hotel – for 1,0–3,9 mm in 2018–2019.

Figure 3. Absolute displacements (and errors of measurements) of monitoring bolts at the UGH building in 2018–2019.

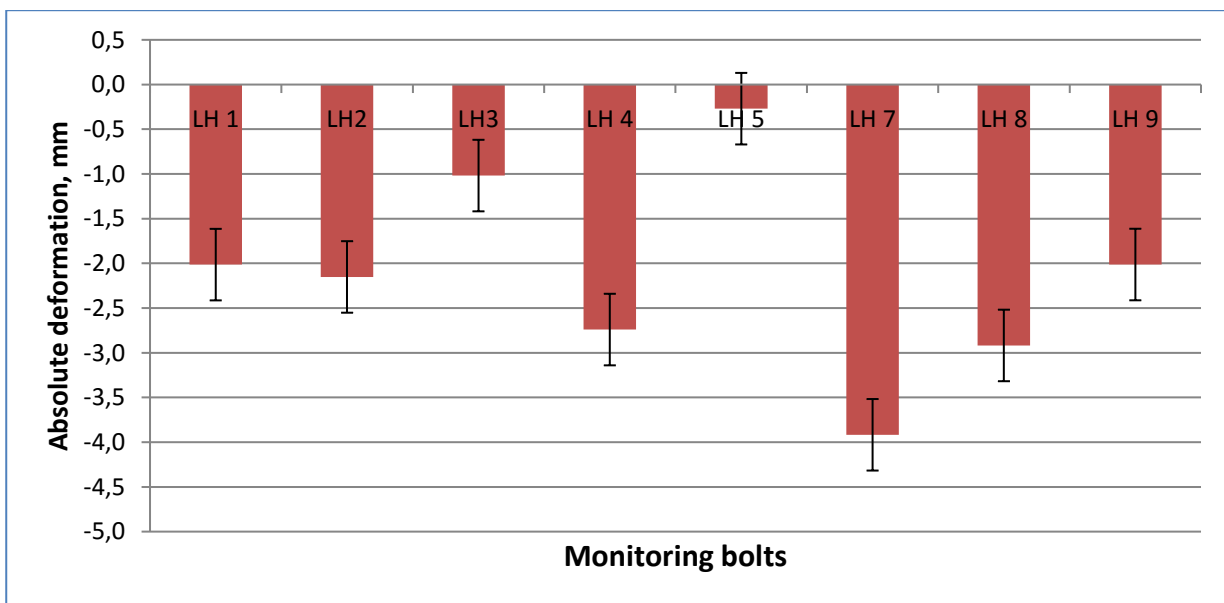
Figure 4. Absolute displacements (and errors of measurements) of monitoring bolts at The Vault Hotel in 2018–2019.

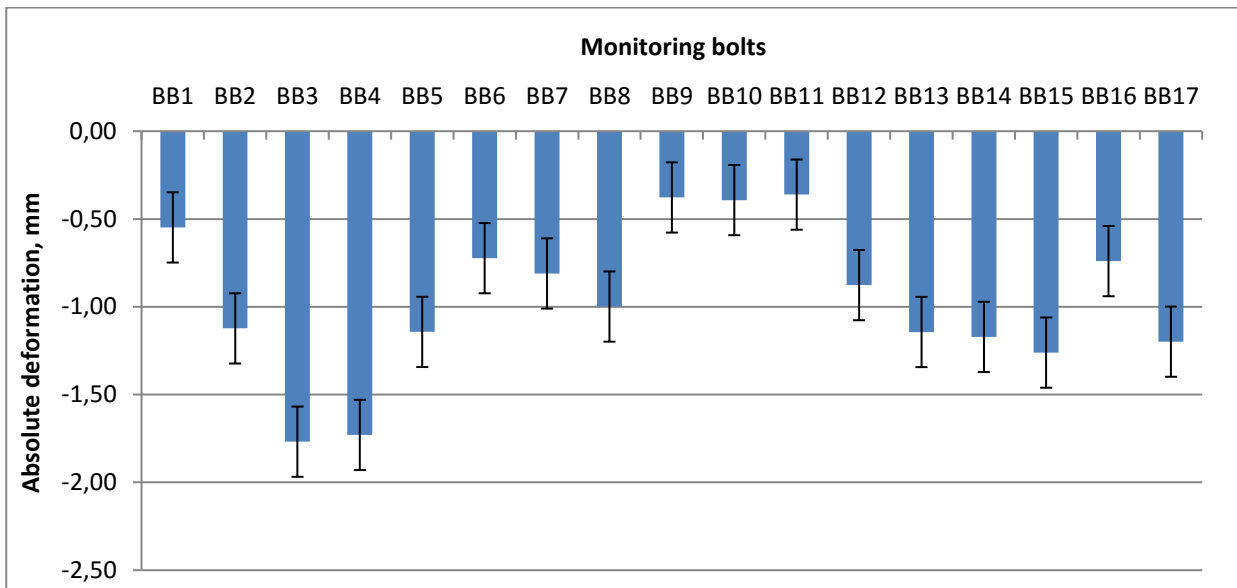
Only preliminary field survey was performed in Barentsburg in 2017, the results of this survey could not serve as a solid base-line data set. Raw data and calculated elevations are presented in the Excel file "Barentsburg\_Raw data\_2018–2019". Elevations of monitoring bolts and standard errors of measurements for 2018–2019 are presented in the Excel file "Barentsburg\_Comparison\_2018–2019" and in Table 9. Absolute displacements are presented in Figure 5. Monitoring bolts of the building "Komplex GRZ" settled in the range 0,4–1,8 mm in 2018–2019.

**Figure 5. Absolute displacements (and errors of measurements) of monitoring bolts at the building "Komplex GRZ" in 2018–2019.**

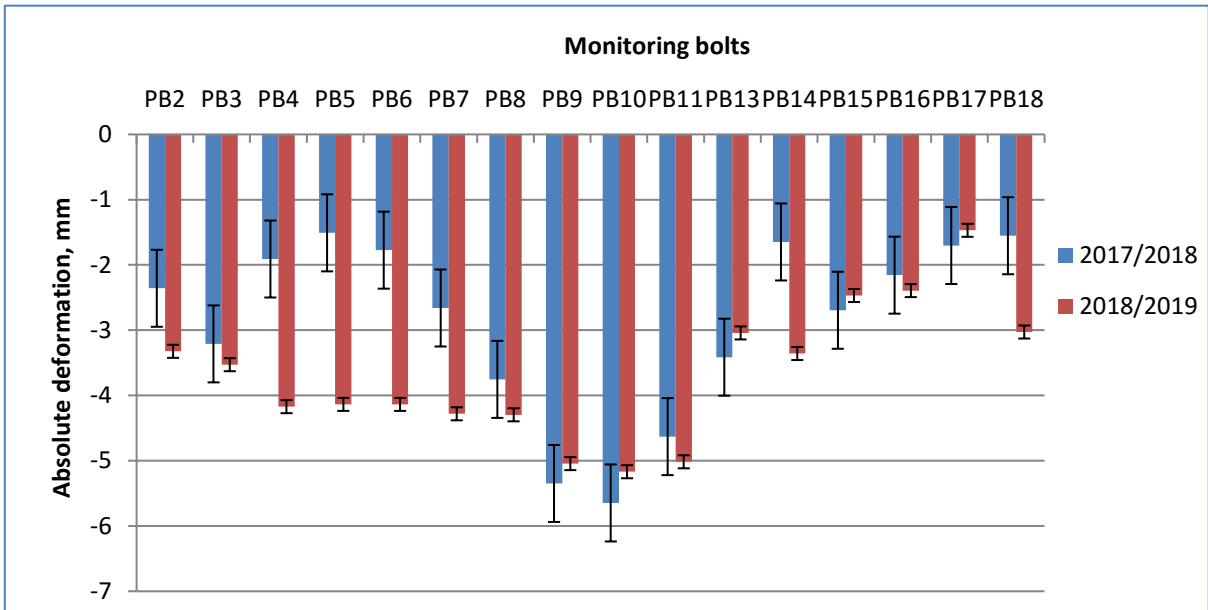
Absolute displacement and errors of measurements of the monitoring points under the multi-purpose garage are in the range 1-2,5 mm/year, with decrease in magnitude for 2018–2019 in comparison to 2017–2018. The latter is opposite to the situation at the outer walls. Settlements under the central part of the garage are smaller than at the outer walls. One may suggest that permafrost conditions are colder (and hence the settlements of piles are smaller) under the building compare to the outer walls due to drier conditions and better surface conditions (absence of snow in the wintertime).

Figure 6. Absolute displacements of monitoring points (and errors of measurements) on the outer walls at the multi-purpose garage in Pyramiden in 2017-2018 and 2018-2019.

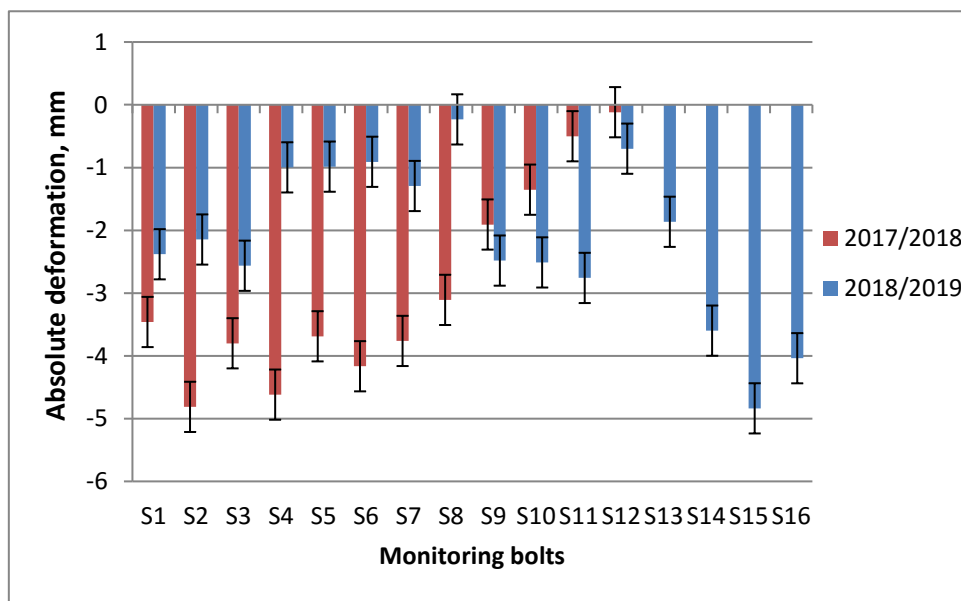
**Figure 9. Absolute displacements (and errors of measurements) at the barack "Låven" in 2017–2018 and 2018–2019.**

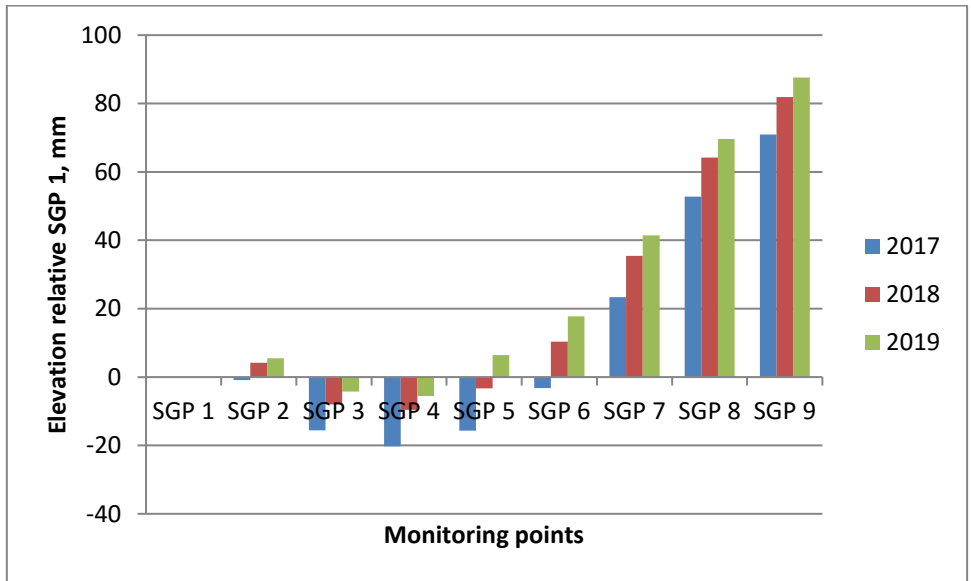
For the "Magnetittlageret" garage, elevations of measured points (for the right-hand side – SGP2–SGP9; for the left-hand side – SGL2–SGL9) were measured in relation to the first channel on each side (for the right-hand side – SGP1; for the left-hand side – SGL1) for 2017–2019 and are presented in Figure 10–Figure 11.

Figure 10. Elevations of points SGP2–SGP9 relative to SGP1 on the right-hand side on the "Magnetittlageret" garage.

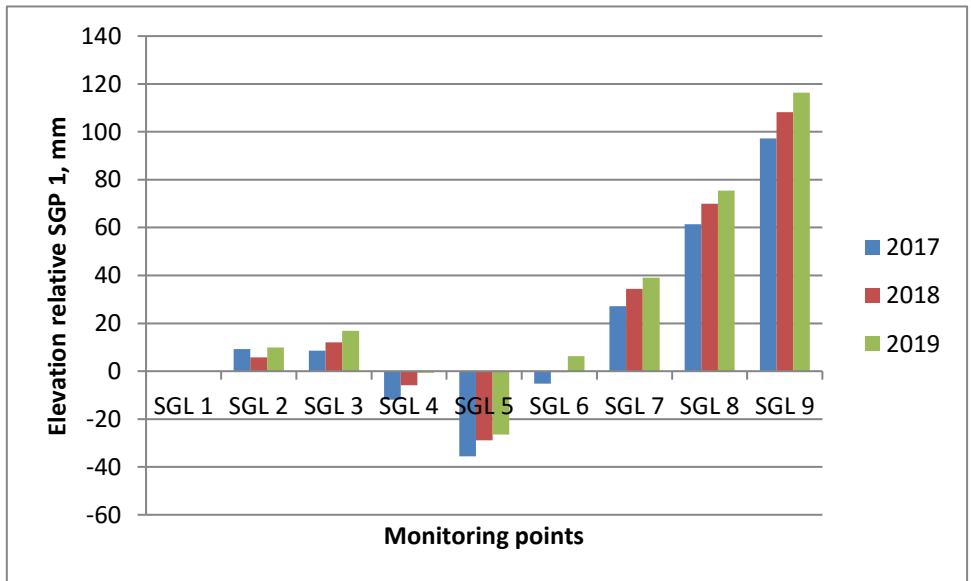
Figure 11. Elevations of points SGL2–SGL9 relative to SGL1 on the left-hand side on the "Magnetittlageret" garage.
